**FIVE-YEAR REVIEW REPORT FOR
NL INDUSTRIES/TARACORP LEAD SMELTER SUPERFUND SITE
Granite City, IL**

**U.S. Environmental Protection Agency
Region 5
Chicago, IL**

3/28/2014

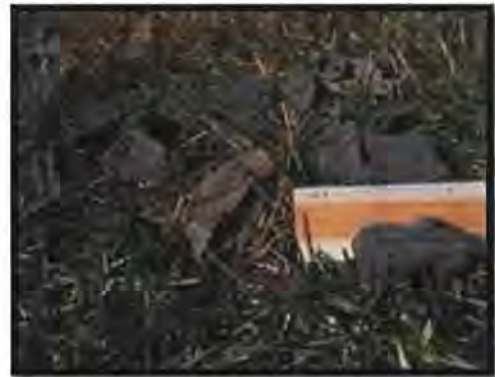
When you dig or excavate at the address indicated above, you may find lead-containing soil or battery case chips. Battery case chips are small (normally 1/2-inch to 2-inch diameter, but can be smaller or larger) pieces of black hard rubber (newer chips may also be other colors or white pieces of plastic) that came from crushing or shredding lead-acid car or truck batteries during recycling. Battery case chips are usually flat but may have a triangular shape if they came from the corner of the battery case.

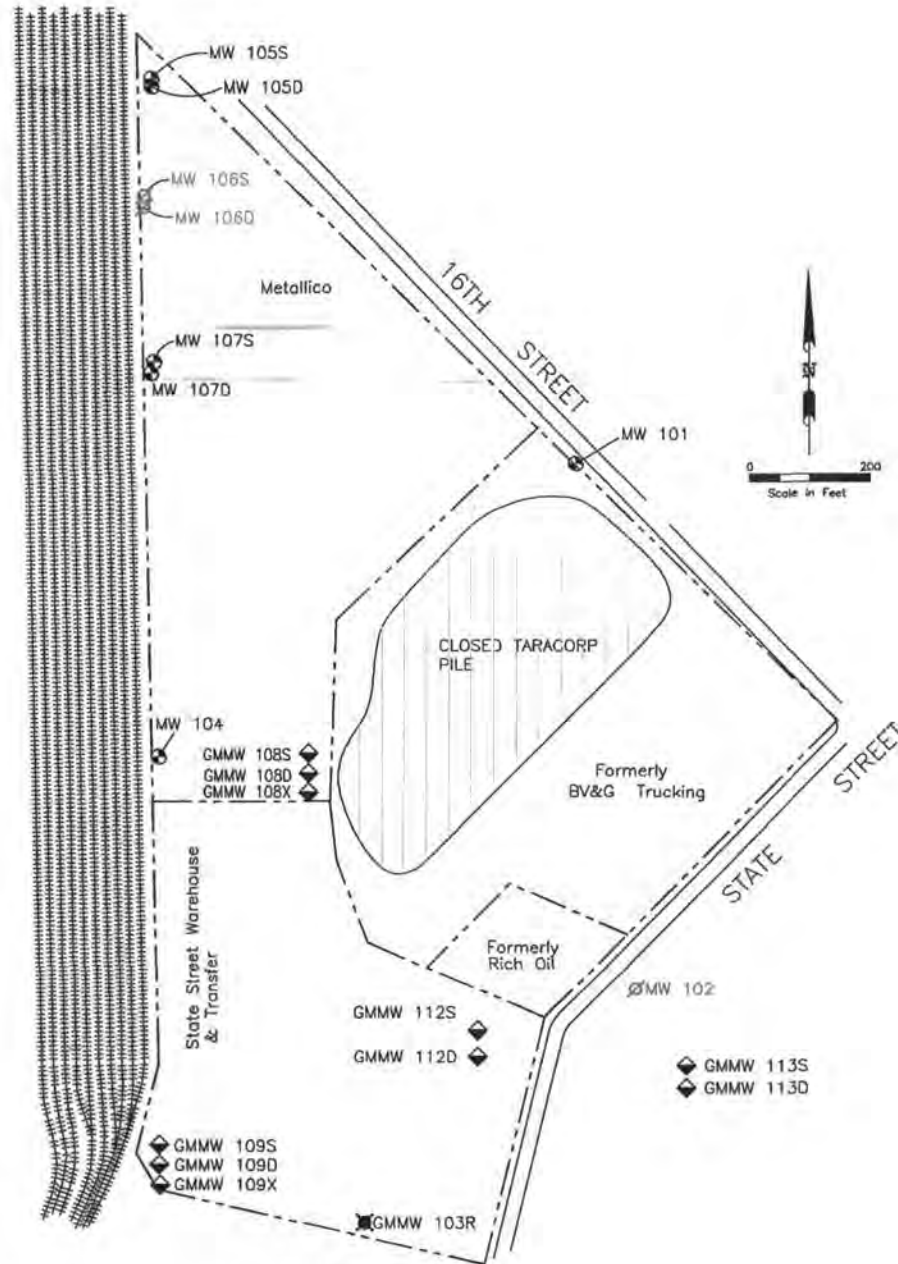
- MW101 EXISTING MONITORING WELL/IDENTIFICATION
 - - - - - PROPERTY LINE
 + + + + + RAILROAD TRACKS
 GMMW 112S,D MONITORING WELL CLUSTER/IDENTIFICATION (Shallow and Deep depths)
 GMMW 109X DEEPER MONITORING WELL/IDENTIFICATION
 GMMW 103R DAMAGED MONITORING WELL/PROPOSED FOR ABANDONMENT
 MW 106S ABANDONED MONITORING WELL/IDENTIFICATION
 S SHALLOW (12-34 FEET BELOW LAND SURFACE)
 D DEEP (27-44 FEET BELOW LAND SURFACE)
 X DEEPER (40-50 FEET BELOW LAND SURFACE)

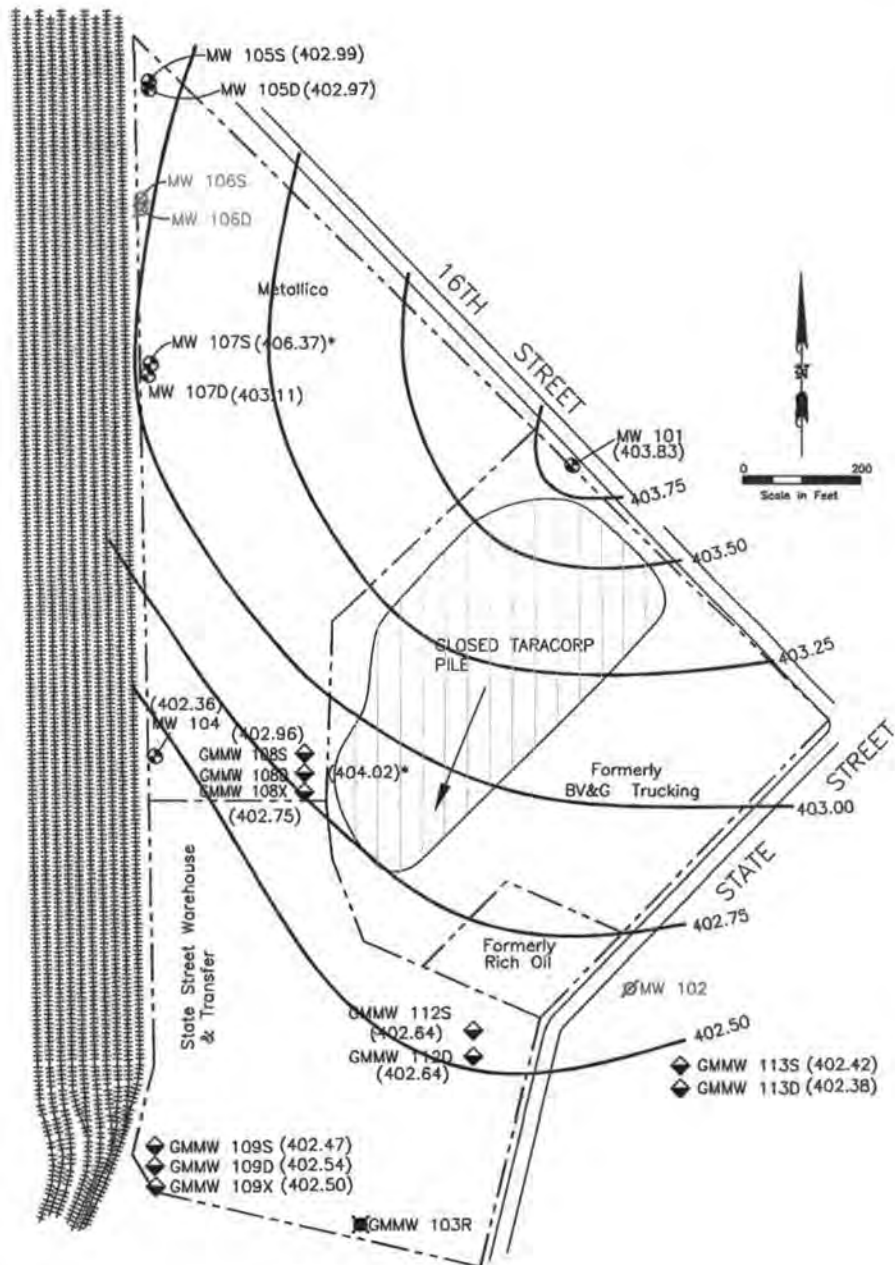
- MW101 EXISTING MONITORING WELL/IDENTIFICATION
- PROPERTY LINE
- +++++ RAILROAD TRACKS
- GMMW 112S,D MONITORING WELL CLUSTER/IDENTIFICATION (Shallow and Deep depths)
- GMMW 109X DEEPER MONITORING WELL/IDENTIFICATION
- GMMW 103R DAMAGED MONITORING WELL/PROPOSED FOR ABANDONMENT
- MW 106S ABANDONED MONITORING WELL/IDENTIFICATION
- S SHALLOW (12-34 FEET BELOW LAND SURFACE)
- D DEEP (27-44 FEET BELOW LAND SURFACE)
- X DEEPER (40-50 FEET BELOW LAND SURFACE)
- (399.64) GROUNDWATER ELEVATION (IN FEET)
- * ELEVATION NOT USED IN CONTOURING
- GROUNDWATER CONTOUR (DASHED WHERE INFERRED)
- 400.0 GROUNDWATER FLOW DIRECTION
